1934 CHEVROLET

## Summary of Work

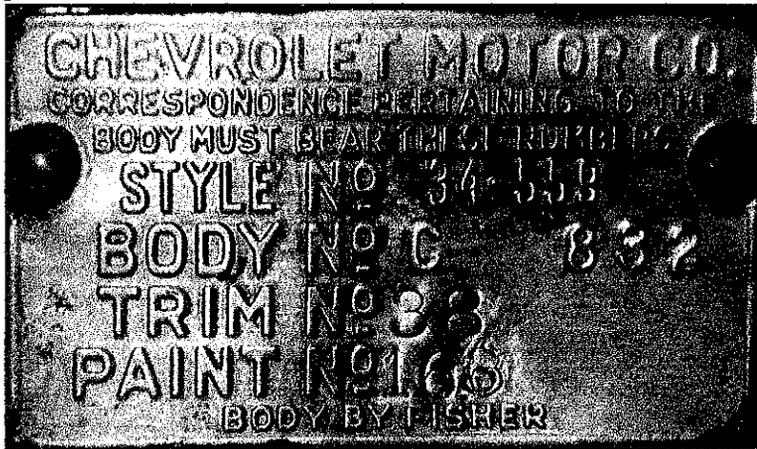
On Cowl Right Hand Side

Fisher Body Number is 11DA092698

This number is on the floor just inside the passenger door by the battery
