## ATTACHMENT 1 - Converting to Front Wheel Tapered Bearings on my 34 DA

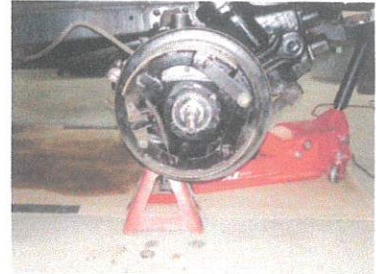
Fig. 176—Cork Washer, Brake Flange Plate, Thrust Washer, Bearing Spacer, showing rotation of assembly

My original front wheel bearings were toast from running loose when I purchased the car five years ago. The picture on the right from the 1934 Chevrolet Repair Manual, page 81, shows the particular assembly of concern. The bearing spacer is a two-part assembly, the bearing spacer itself and its cover.

A brief review of the knee-action operation will aid in understanding my concern. The spindle moves up and down on an arc described by the load bearing arm. The brake flange plate is held in a stable fixed position by the radius rod. For every degree the spindle moves up or down, the brake flange plate will rotate on the spindle journal the same number of degrees.

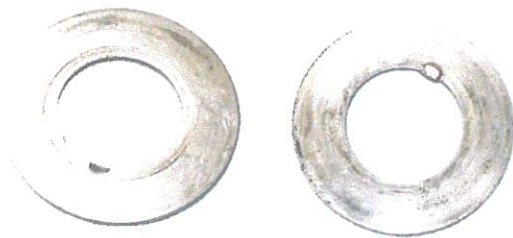
These two pictures show the wear that occurred on the bearing spacer from running with loose bearing. Note, the tang has been well worn down and the other side shows significant wear. The OD of that wear is about 1.75 inches and the wear area is about 0.25 inches wide. It is this wear that confirms the inner bearing cone has a smaller ID than that of the cover and the bearing cone slides through to mate with the bearing spacer. The other bearing spacer has similar wear.

The picture of the thrust washer shows the wear that was on each thrust washer.
